TECHNICAL BRIEF

The bell tower, also known as Kamban Pirg, is situated in the eastern part of the monastery complex – east of the church and south of the St Sava tower. At the time of its inception this was a defensive tower situated in front of the monastery walls. Over time it lost its defensive function and its usage changed. There are six floors, that over time have been used as:

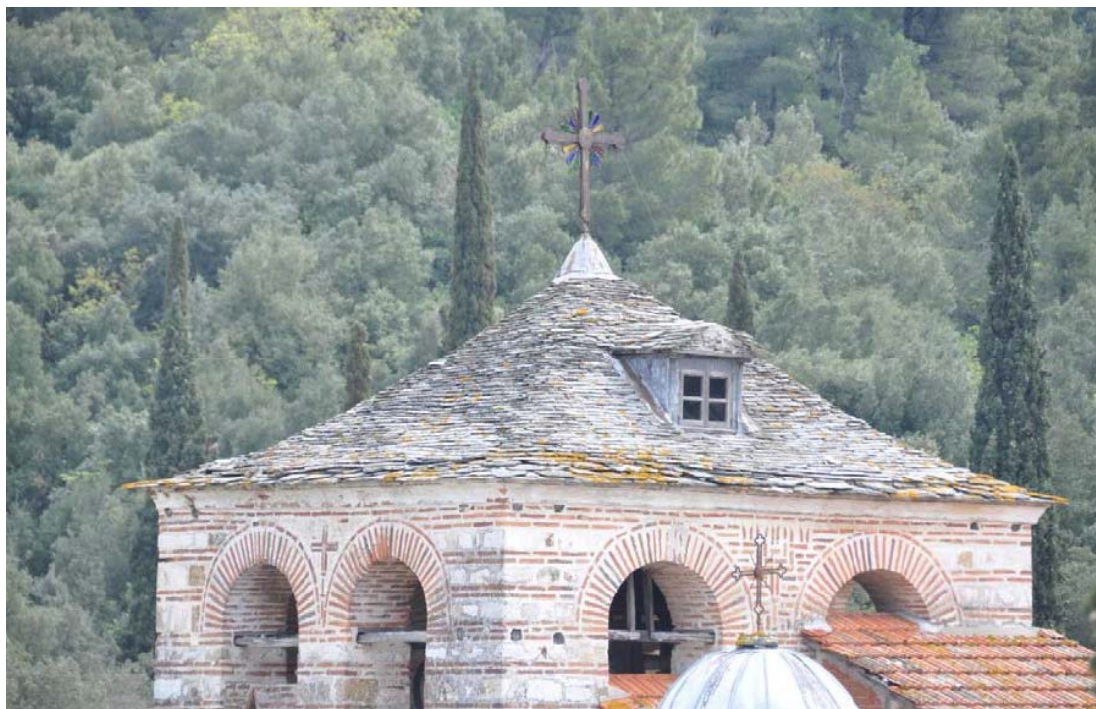
PICTURE 1 – VIEW OF THE BELL TOWER’S ROOF

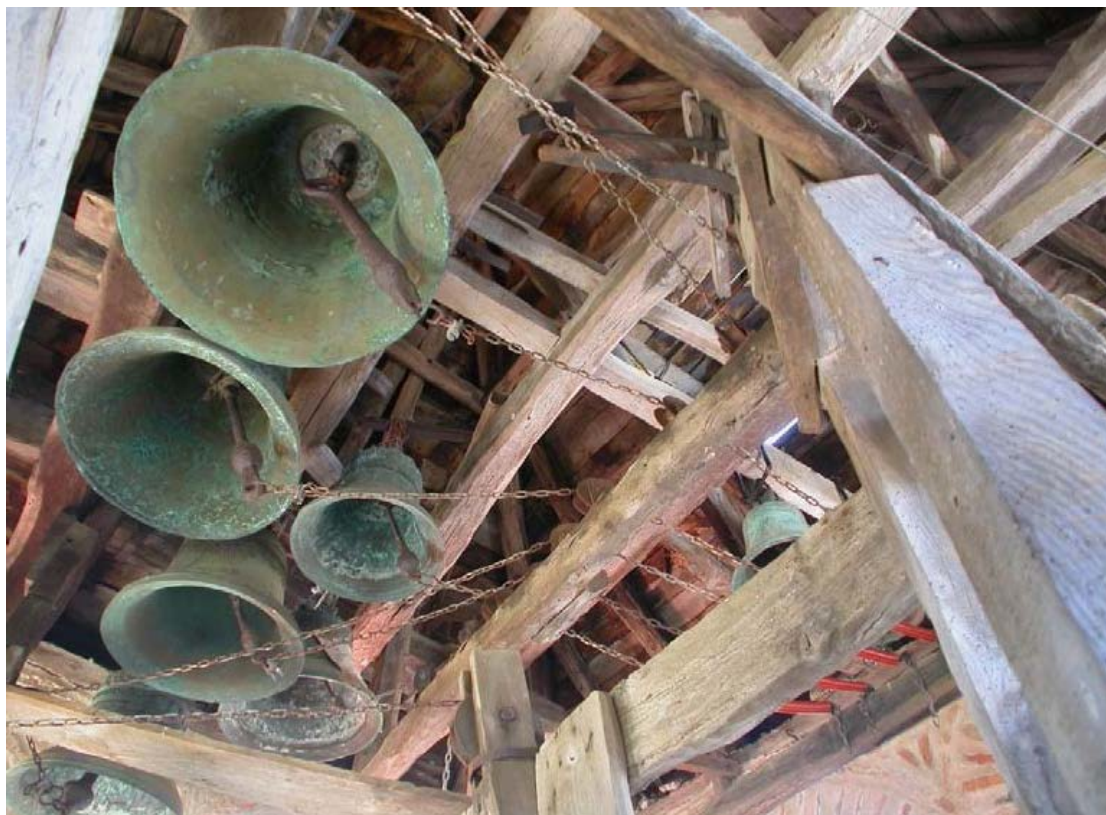
PICTURE 2 – BELL SUPPORTING STRUCTURE

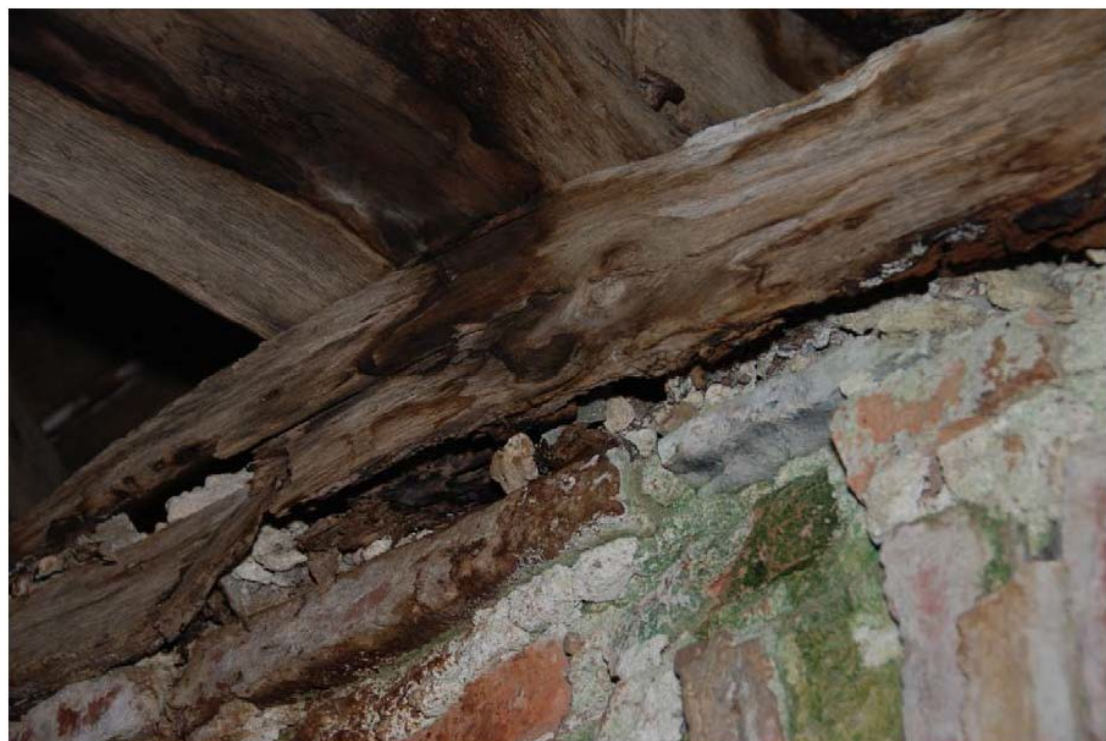
PICTURE 3 – DAMAGE TO THE WOODEN STRUCTURE CAUSED BY DAMP

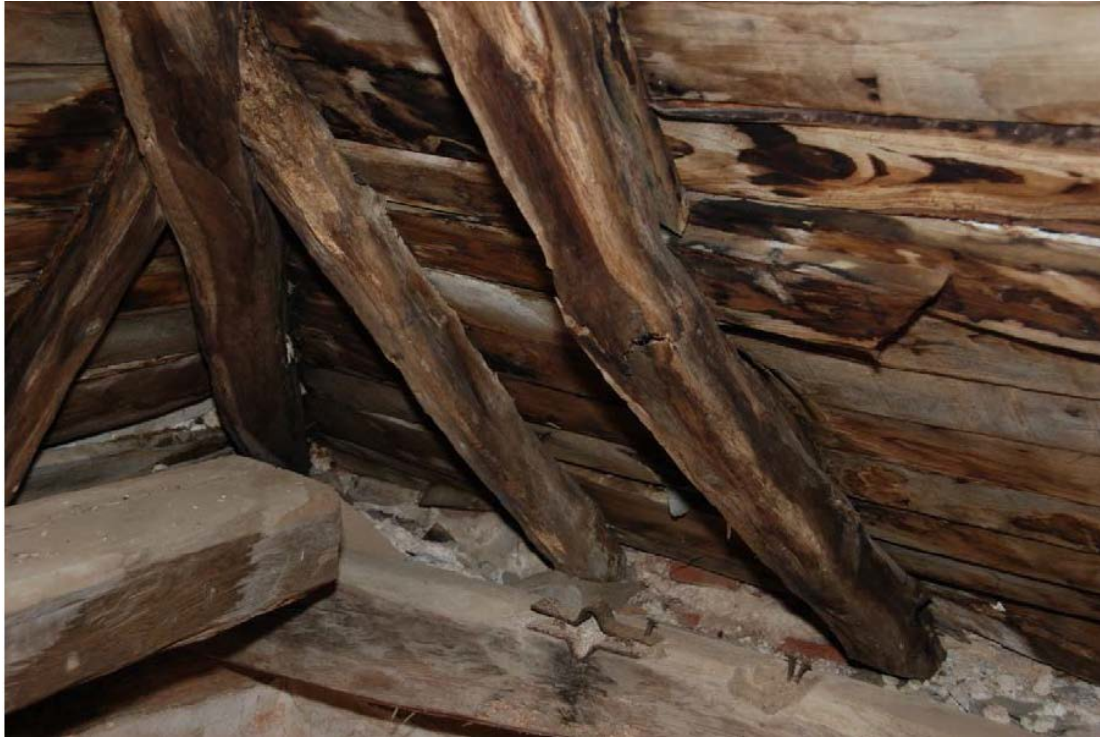
PICTURE 4 – DAMAGE TO THE WOODEN STRUCTURE – STRUT AFFECTED BY DAMP
